KÖSTER Crisin 76

The horizontal barrier to stop rising damp

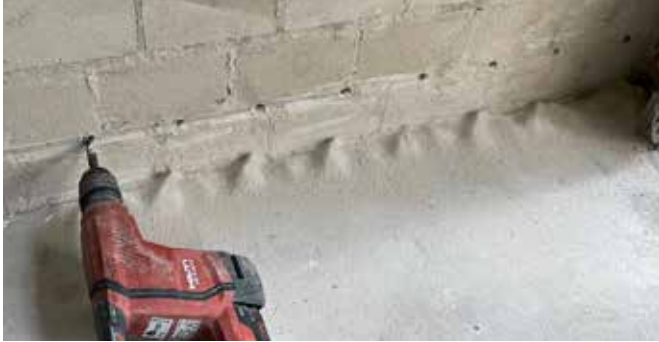
Horizontal drilling in the bed joint

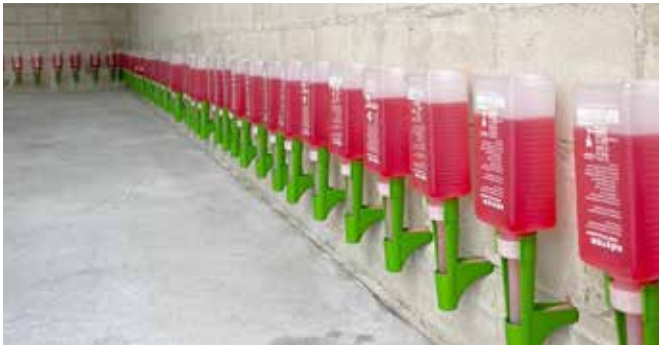
Installation of the horizontal barrier

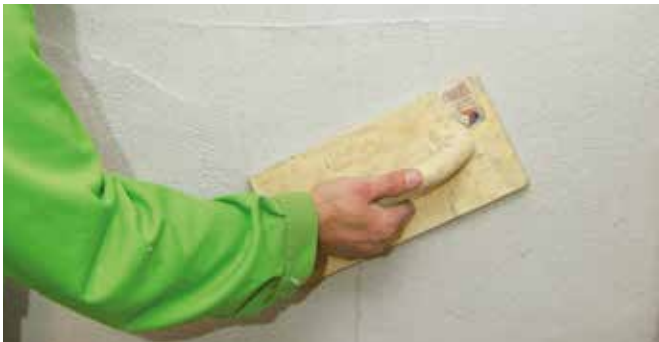
Diffusion open KÖSTER Restoration Plasters

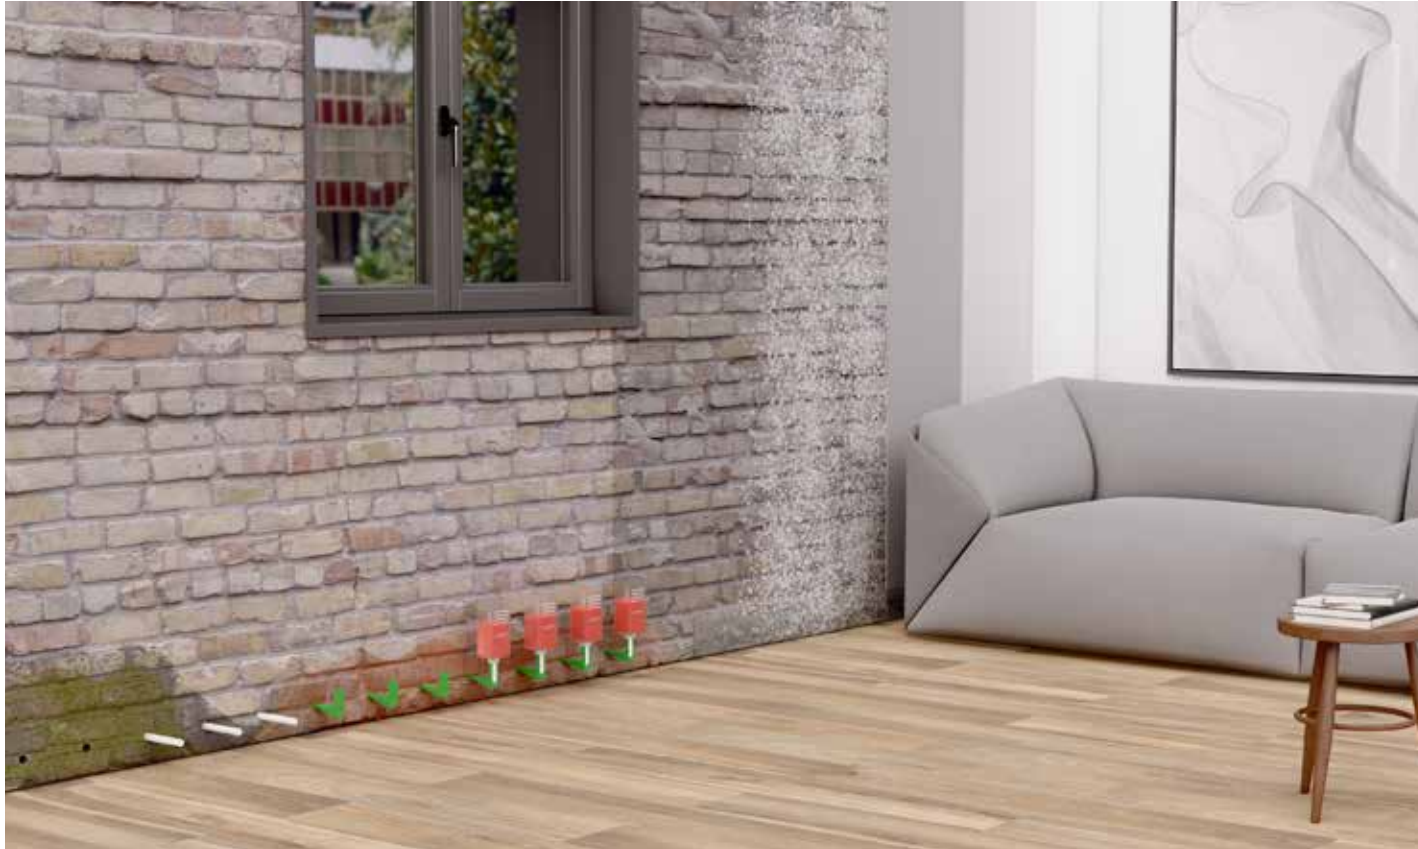
KÖSTER Crisin 76
Very low viscosity synthetic resin for waterproofing against rising damp (wicking moisture).

KÖSTER Suction Angle
Plastic angle for the pressureless and material saving installation of horizontal barriers.

KÖSTER Capillary Rods
The KÖSTER Capillary Rod releases the injection liquid evenly and directly to the masonry.

The advantages of the Suction Angle System:

- Can be applied to perforated brick and cracked or hollow masonry without having to fill the voids beforehand
- No subsequent injections required
- One-time installation, success guaranteed
- Easy installation, horizontal drilling
- Reusable bottles and suction angles
